LA FARGE MUNICIPAL UTILITIES

TWO YEAR REPORT DOCUMENTING COMPLIANCE WITH THE PREVENTATIVE MAINTENANCE PLAN

La Farge Municipal Utilities

INFRARED REPORT

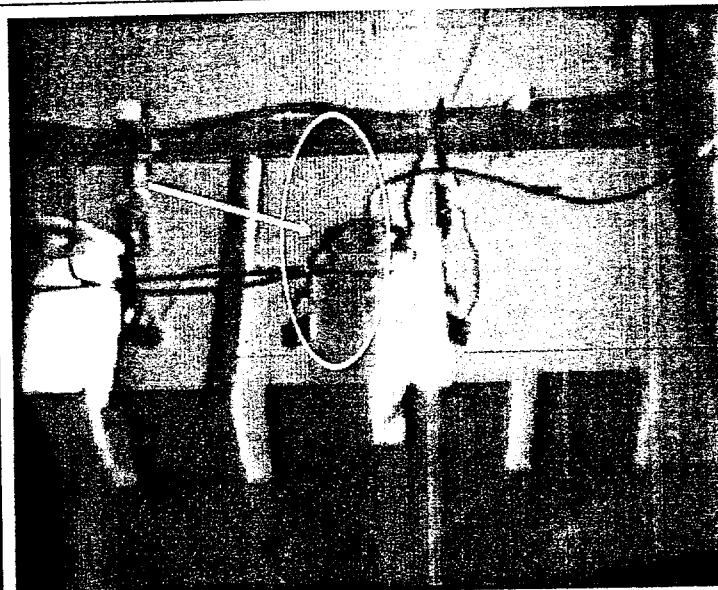
Problem # 1

Equipment: CROP MAIN OFFICE TRANSFORMER BANK

Location: CROP MAIN OFFICE

Problem Area: WEST SECONDARY BUSHING ON EAST TRANSFORMER

Extreme Risk
High Risk
XX Medium Risk
Low Risk

Loose Connection
Overload
Check for Cause

Comments: WEST 37 C
EAST 21 C

Clean & Tighten
Repair/Replace
Check for Cause

Follow Up Action: *Cleaned & tightened*

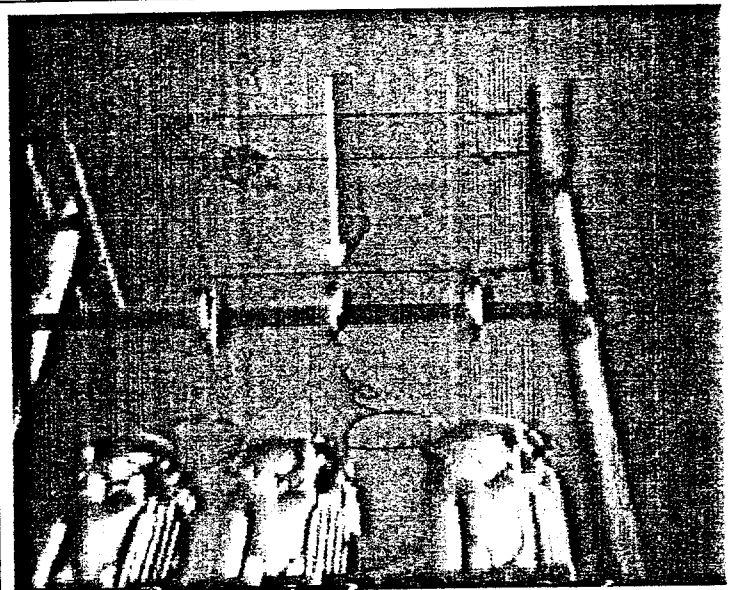
Problem # 2

Equipment: SAWMILL TRANSFORMER BANK PRIMARY FUSES

Location: SAWMILL

Problem Area: CENTER PHASE TOP FUSE / LUG CONNECTION

Extreme Risk
High Risk
XX Medium Risk
Low Risk

XX Loose Connection
Overload
Check for Cause

Comments: +5 C RISE.
CHECK ALL CONNECTIONS.

XX Clean & Tighten
Repair/Replace
Check for Cause

Follow Up Action: *Cleaned & Tightened*

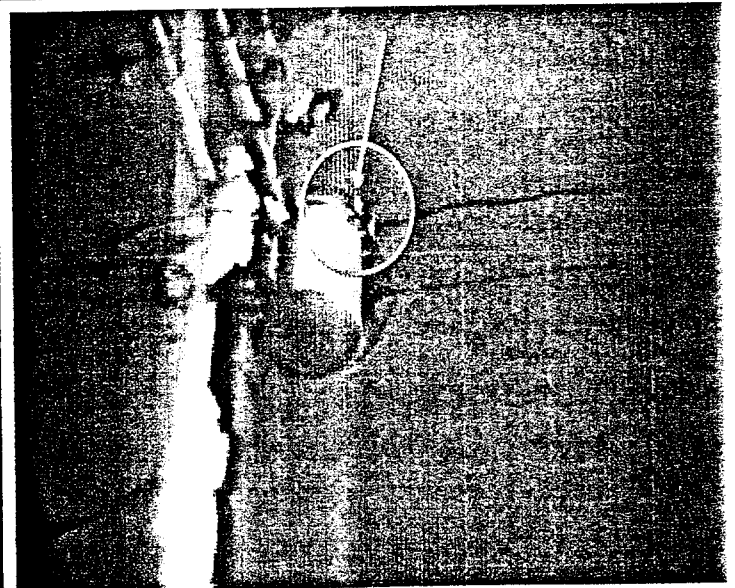
Problem # 3

Equipment: ELM STREET TRANSFORMER

Location: ELM STREET

Problem Area: SOUTH SECONDARY BUSHING

XX Extreme Risk
High Risk
Medium Risk
Low Risk

XX Loose Connection
Overload
Check for Cause

Comments: +20 C RISE.
CONDUCTOR IS CHARRED.

XX Clean & Tighten
Repair/Replace
Check for Cause

Follow Up Action: *SPLIT up Loading with addition of another Transformer mid Block, checked connection on transformer in question, Tightened Lug*
Date: *9-5-01* Performed By: *Wayne, Dan, Phil*
